Contract #: 04-0120F4

# WELDING INSPECTION REPORT

**Project Name:** SAS Superstructure **OSM Arrival Time:** 1500 **OSM Departure Time:** 300 **Prime Contractor:** American Bridge/Fluor Enterprises, a JV

34-0006 **Bridge No: Component:** OBG

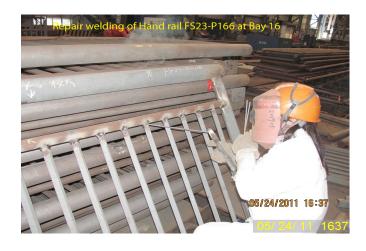
For further information see below pictures:-

Unless otherwise noted, all work observed on this date appeared to be in general compliance with the applicable contract documents.
